Anticipating Economizer Failure During Small-Packaged System Installation

Seventy-percent failure rate seen in this study

By PETER C. JACOBS,
Architectural Energy Corp.,
Boulder, Colo., and
MARK A. WILLIAMS,
The New Buildings Institute
White Salmon, Wa.

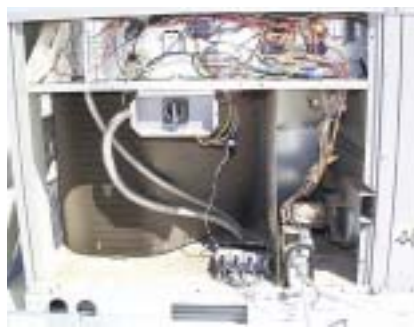
Photo A. Short-term monitoring of rooftop unit. Note portable, battery powered data logger in bottom-center of the photo.

If the unit had an airside economizer, the minimum outdoor air position potentiometer was adjusted to test the operation of damper motors and linkages. The economizer outdoor-air temperature sensor was cooled down using a "cool" spray, simulating cool outdoor air conditions and the response of the economizer was observed. Finally each unit was monitored over a 2 to 3 week period using portable, battery-powered data loggers to observe unit operation over a variety of operating conditions (see Photo A).

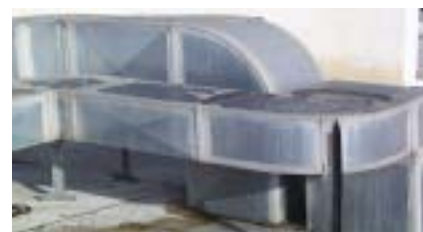
Photo B. Ductwork running across the roof, and ductwork located in an unconditioned plenum should be sealed and insulated to prevent energy loss.

Leaky ductwork is a common installation problem plaguing small commercial systems. Ducts in small commercial buildings are often installed in a plenum space between the roof and a suspended ceiling. Insulation is often installed on the ceiling tiles, placing the duct work outside the thermal envelope of the building or above the roof surface. (See photo B.) A recent study of 350 small commercial HVAC systems in Southern California¹ found that 85 percent of the systems tested had excessive duct leakage.

The average combined supply and return leakage in these systems exceeded 35 percent of the total air volume, causing energy waste and poor thermal comfort. Cooling energy savings from sealing duct systems approaches 20 percent when duct systems are located outside the conditioned space. Peak cooling loads are reduced even more when ducts are sealed since attic air that is very warm under these conditions. Our study found that duct leakage sealing can be beneficial even when the insulation is installed at the roof deck, improving the overall efficiency of the HVAC system by 5 percent.

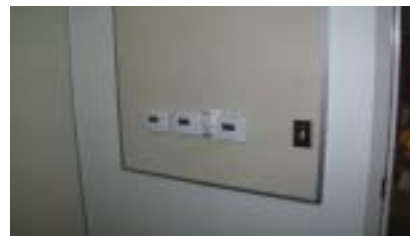
tion. Location of the thermostat can dramatically affect system loads and occupant comfort. Since the system responds to the air temperature at the thermostat, proper location is key to comfort and energy efficiency. Locating several thermostats in the same general area with conflicting heating and cooling setpoints can invite problems with simultaneous heating and cooling, where adjacent units “fight” each other to maintain selected setpoints (see photo C).

Photo C. Thermostats controlling three different units serving three different computer labs at a community college are located in the corridor, where they are unable to effectively sense the temperature of the rooms they are controlling.

Commercial (not residential) thermostats should be used to provide continuous fan operation and ventilation during occupancy. They will also control the off-hour ventilation cycle and allow daily scheduling of fan operation. Continuous fan operation is critical for ensuring that adequate outdoor air is provided to mechanically ventilated spaces. Intermittent fan operation can reduce the effective ventilation rate of a space by a factor of three.
